April 7, 2004

Errata Document for CY7C632xx / enCoRe™ USB Low-speed USB Peripheral Controller

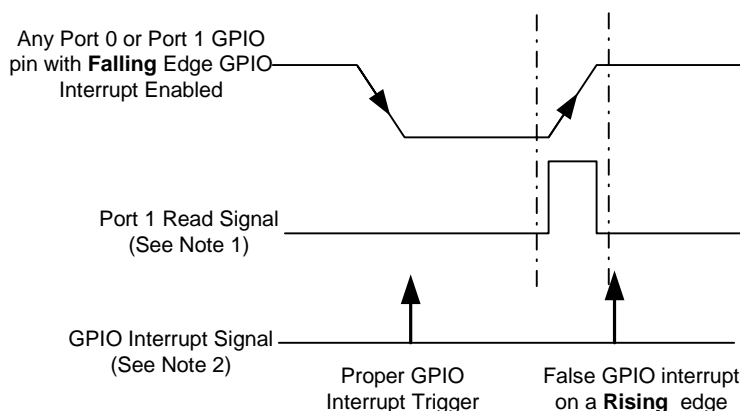
When a falling edge interrupt is enabled for a GPIO pin, reading the GPIO Port 1 coincident to a rising edge of that GPIO signal may generate a false GPIO interrupt.

The chip enters the GPIO Interrupt Service Routine (ISR) in error.

Workarounds will need to be tailored to individual applications based on the flexibility of changing the GPIO usage, the timing of the GPIO interrupt sources and firmware interrupt latencies.

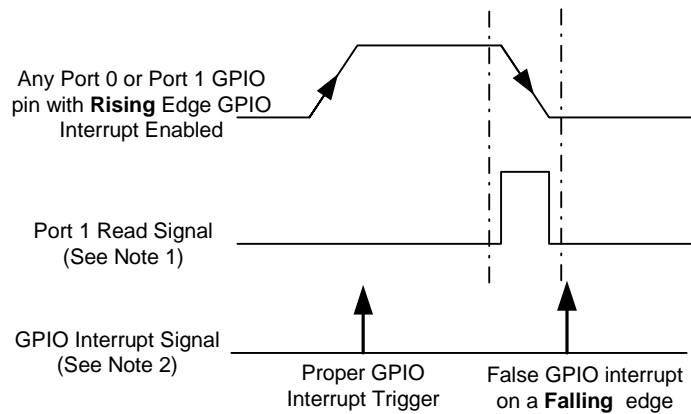
When a rising edge interrupt is enabled for a GPIO pin, reading the GPIO Port 1 coincident to a falling edge of that GPIO signal may generated a false GPIO interrupt
