PM5363

TUPP+622

SONET/SDH TRIBUTARY UNIT PAYLOAD PROCESSOR FOR 622 MBIT/S INTERFACES

DATA SHEET ERRATA

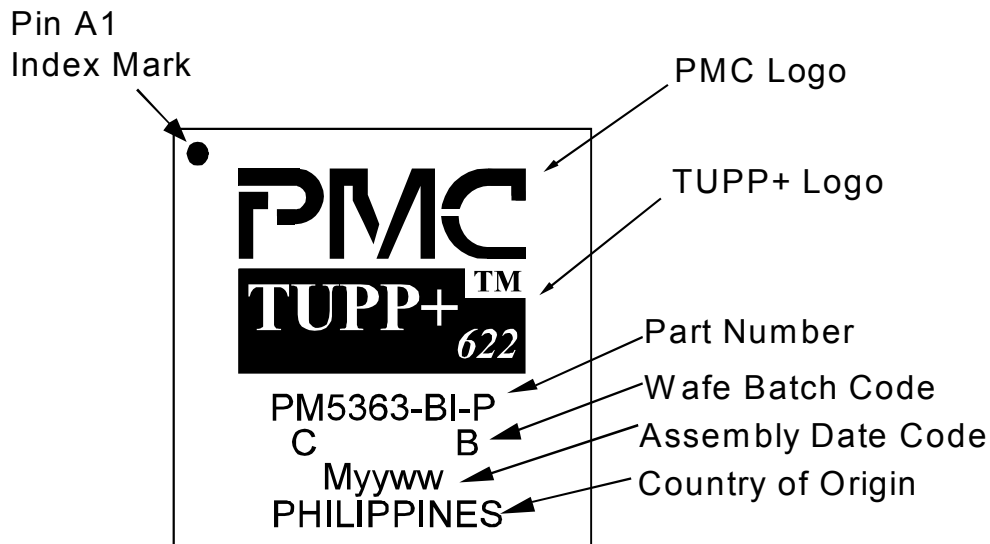
TOP VIEW
SCALE 1.5:1
(APPROX.)

The information in this document applies only to the PM5363 TUPP+622 Revision B device. The device revision is marked at the end of the wafer batch code on the face of the device.
